**THERMAL-STRUCTURAL  
EVALUATION OF  
Ti-6Al-4V  
THERMAL PROTECTION  
SYSTEM PANELS**

By H. L. Eidinoff and L. Rose

Prepared under Contract No. NAS 1-12277 by  
Grumman Aerospace Corporation  
Bethpage, New York 11714

NATIONAL AERONAUTICS AND SPACE ADMINISTRATION

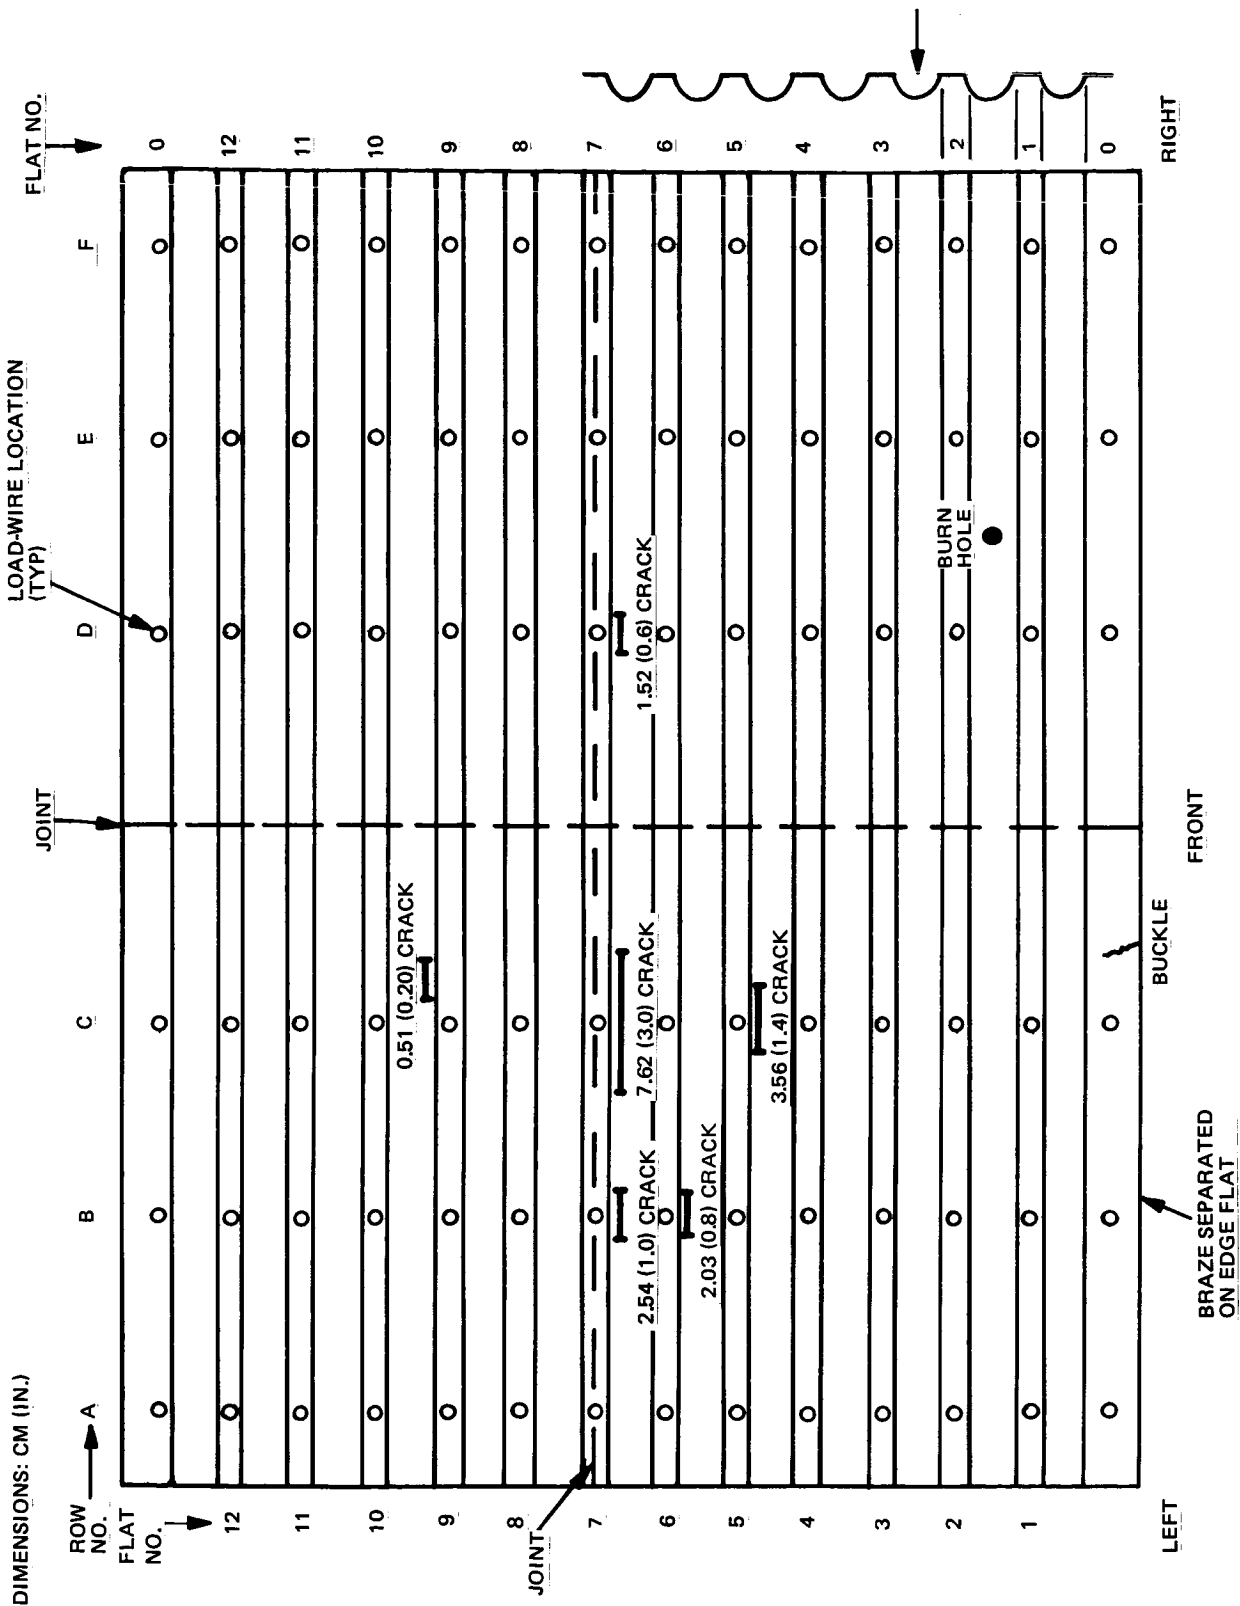
Five major cracks and a minor crack were observed on the metallic frontface. A map showing the location of these cracks is shown in Fig. 5-17. Note that all the cracks run parallel to the beads and that all the major cracks, those longer than 0.625 cm (1/4 in.), lie at the junction of a flat and a bead in the vicinity of a loading point. There is a stress concentration at these points due to the introduction of the concentrated load from the loading wires. These stresses are added to the stress in the bead, which occurs when the bead flexes to take up the thermal expansion in the lateral direction. It is possible that if the load was a uniform pressure instead of a

Fig. 5-17 Post-Test Inspection Surface Map, Run No. 100

pattern of discrete concentrated loads, most of the cracking in the facesheet would not have occurred. Recall that the first large crack was observed after the 88th cycle. In spite of the cracking, however, catastrophic failure did not occur, and the panel continued to sustain the applied loads and temperature.

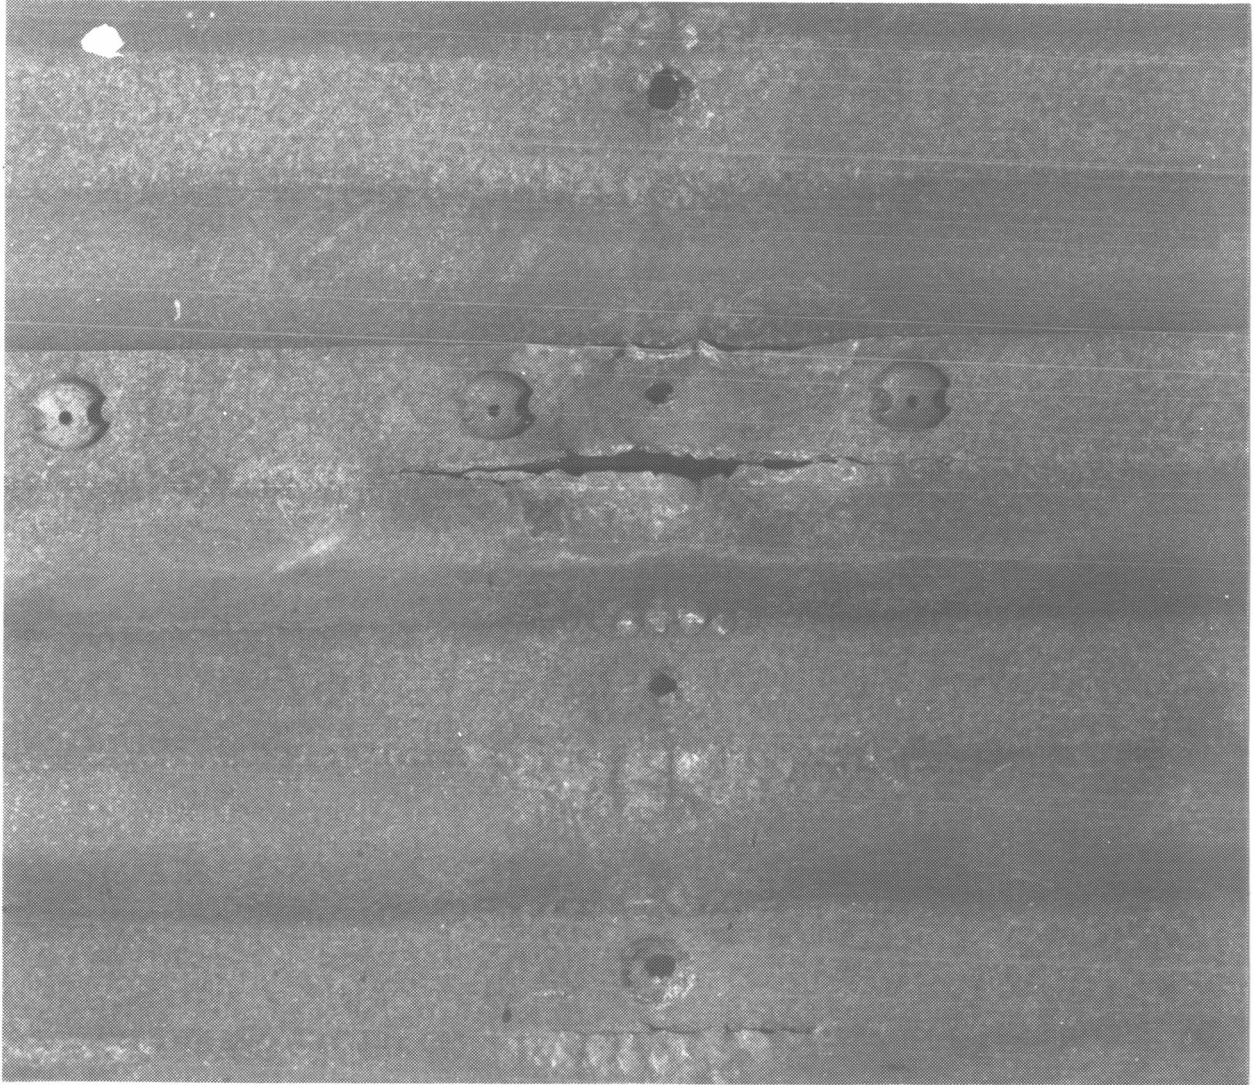
A photograph of the 7.6-cm (3.0-in.) crack located at loading point C-7 is presented in Fig. 5-18. This is the largest crack in the panel and was the first one detected (after cycle 88). Also visible is the 3.6-cm (1.4-in.) crack located at loading point C-5.

**Fig. 5-18 Surface Cracks After 100 Cycles**

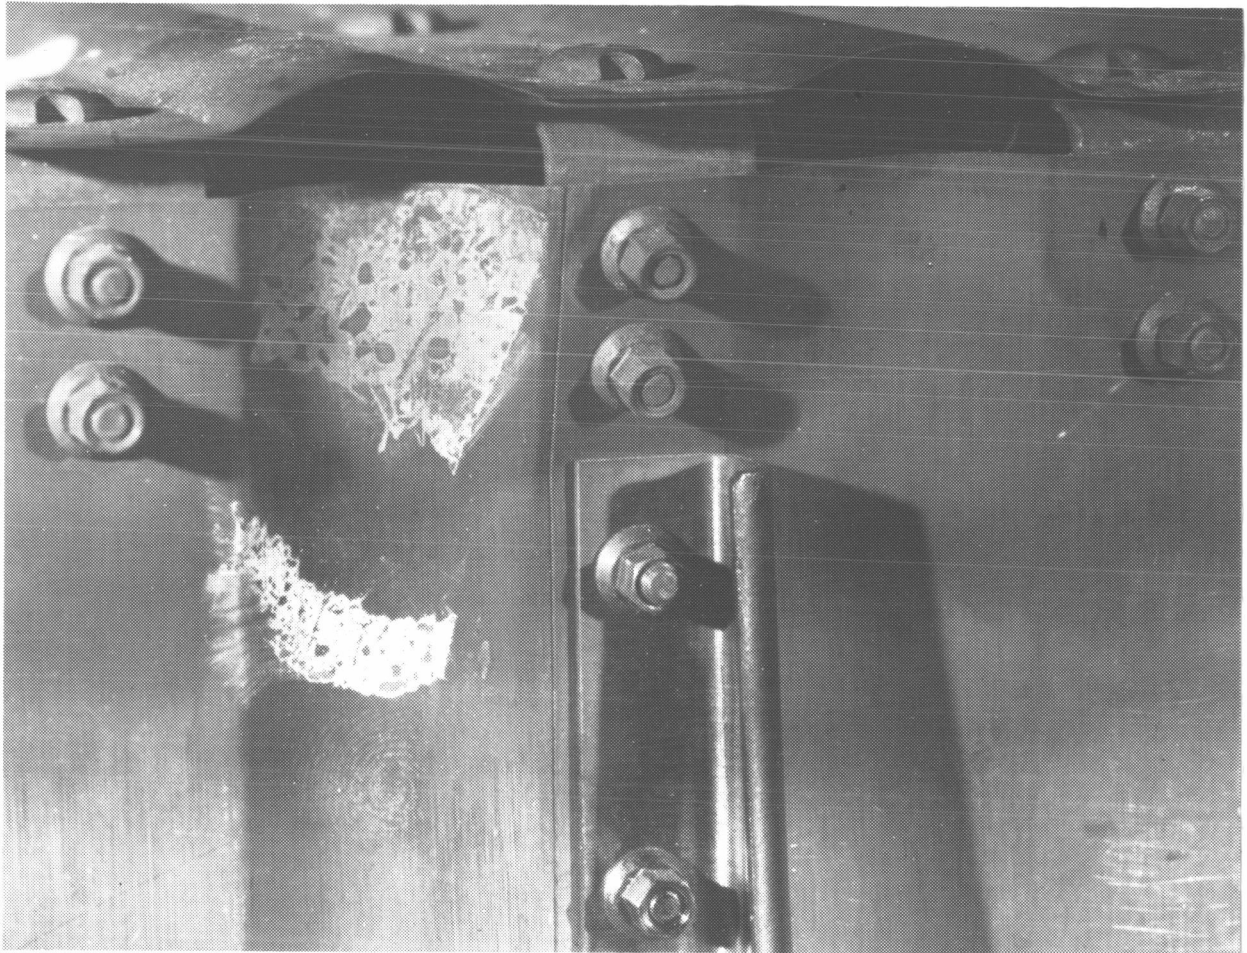
The supports at the ends of the panel were designed to take out horizontal loads. This is accomplished by inclusion of drag brackets situated along these supports at a 19-cm (7.5-in.) pitch. For this test article, the supports at the left and right ends had three drag brackets each. The drag bracket comes up to about 1.3 cm (1/2 in.) of the top of the support, and provides no stiffening above this point. It was observed that just above two of the drag brackets on the left end support there were kinks in the support indicating a large horizontal force to the left was sustained there.

A photograph of the kink above the center drag bracket is shown in Fig. 5-19. The horizontal force may have been due to failure of the expansion joint in the center of the panel to allow free expansion. During panel heating, the temperature gradient through the corrugation can produce bowing upward of the panels and consequent pressure between the overlapped beaded sheets in the expansion joint. Hence, thermal expansion could produce a horizontal force in the proper direction to create the noted kinks.

**Fig. 5-19 Kink in Support Rib**

- Improvement in the design of the drag brackets of expansion joints to prevent kinking of the supports resulting from the horizontal loads
- A study to examine the fastening scheme in the longitudinal seam between panels to determine if the fasteners initiate cracks

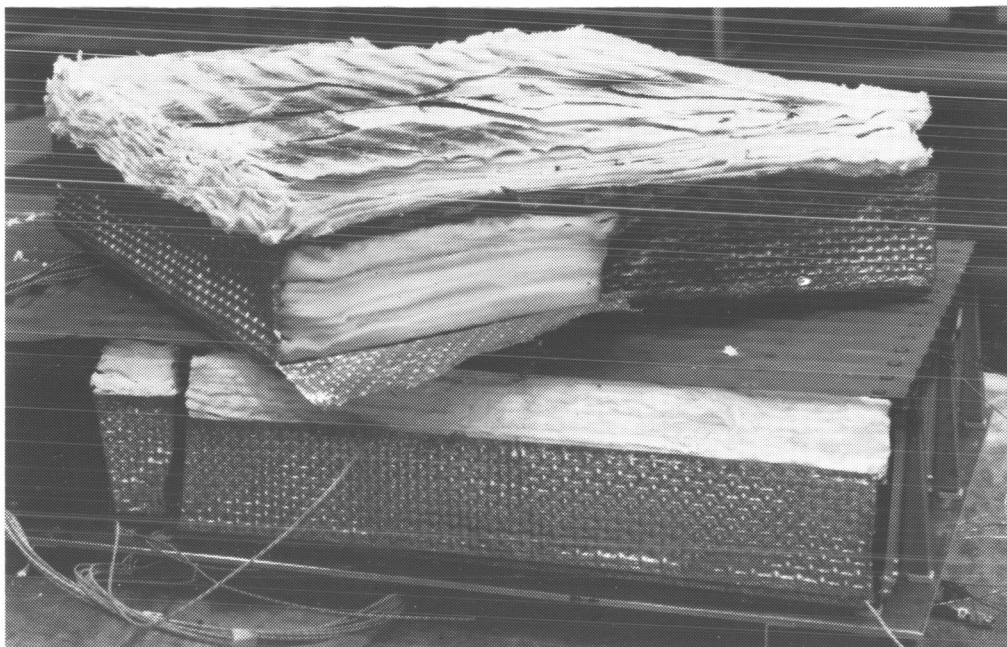
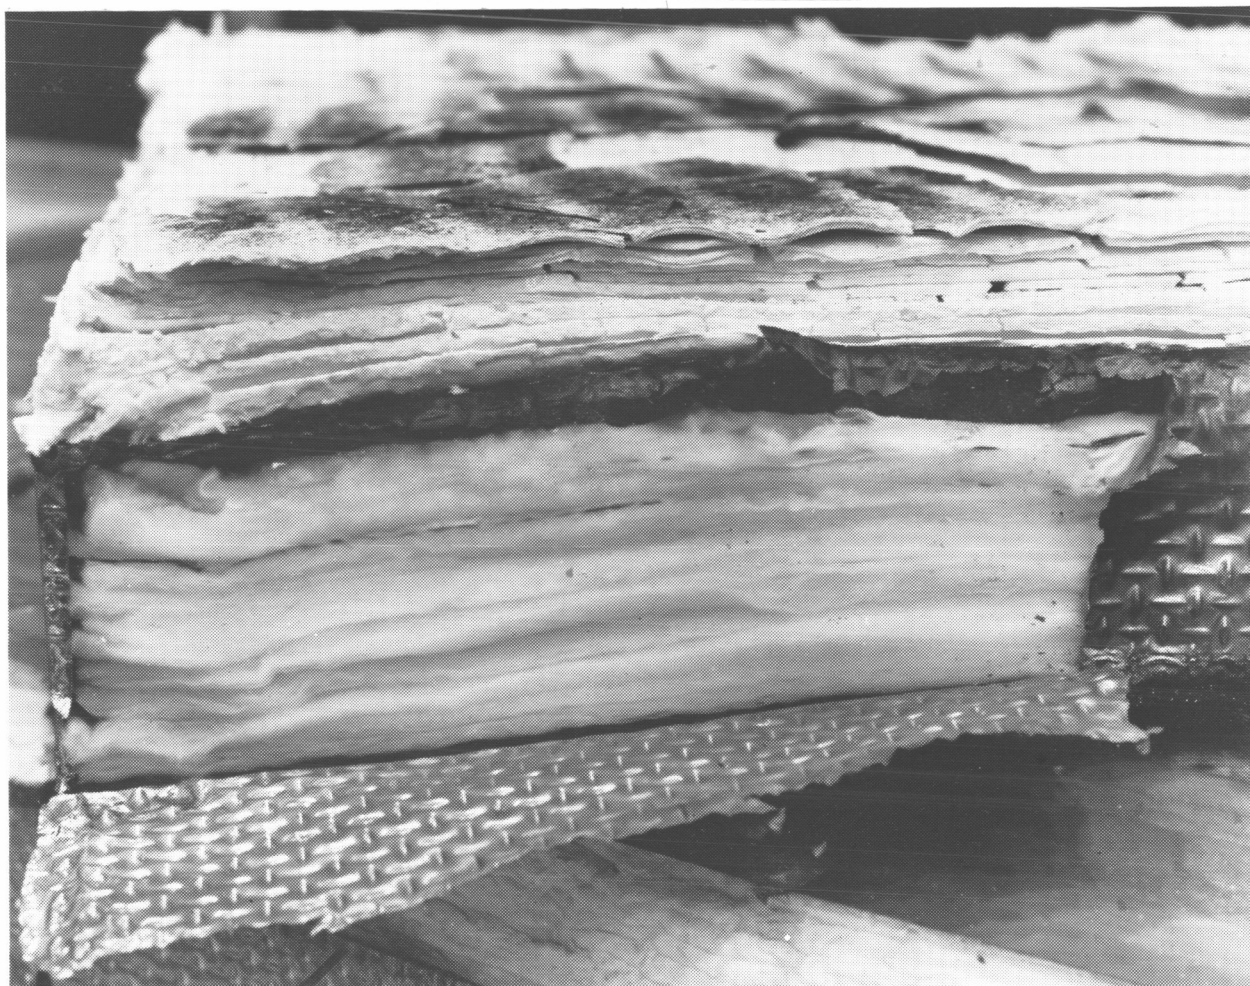
The insulation package was removed from the test panel and examined. Photographs were taken and are presented in Fig. 5-20 and 5-21. The Dynaflex showed considerable shrinkage - about 7% - along the top surface where it was operating at 1200° C (2200° F) and considerably less at lower temperatures. For the test article, the shrinkage reduces rapidly as distance from the 1200° C surface increases, and is negligible at the backface of the Dynaflex, which is 4.0 cm (1.57 in.) from the top surface.

Considerable oxidation of the Inconel bagging around the Protecator was visible, extending from the top surface, where the Dynaflex meets the Protecator, to about one-third of the way down the sides. However, no holes in the foil were found. One side of the bagging was removed to examine the Protecator. Both the reflective screens and the Astroquartz appeared to be in excellent condition. No damage was observed on the polyimide-foam backface bagging.

Fig. 5-20 Insulation After 100 Cycles

Fig. 5-21 Insulation After 100 Cycles
